Report No. VTRC 05-R31	Report Date June 2005	No. Pages 36	Type Report: Final Period Covered: August 2003-April 1, 2005	Project No.: 73849
				Contract No.
Title: Use of Soil Stabilizers on Highway Shoulders				Key Words: shoulders, soil stabilizers, soil additives, aggregates, shoulder reclaimer, pavement edge drop-off
Author: Daniel S. Roosevelt, P.E.				
Performing Organization Name and Address: Virginia Transportation Research Council 530 Edgemont Road Charlottesville, VA 22903				
Sponsoring Agencies' Name and Address Virginia Department of Transportation 1401 E. Broad Street Richmond, VA 23219				
Supplementary Notes				
<p>Abstract</p> <p>This study evaluated soil additives as stabilizers for aggregate and topsoil shoulders. Its purpose was to determine (1) the effect soil stabilizers have on the strength and stability of soil shoulders, and (2) the costs and benefits of using stabilizers versus paving the shoulder or maintaining the shoulder as originally composed. The study used test and control sections to assess two stabilization products, Soiltac and Centrophase AD, used with one type of shoulder material (crusher run stone). The experimental sections were installed at o

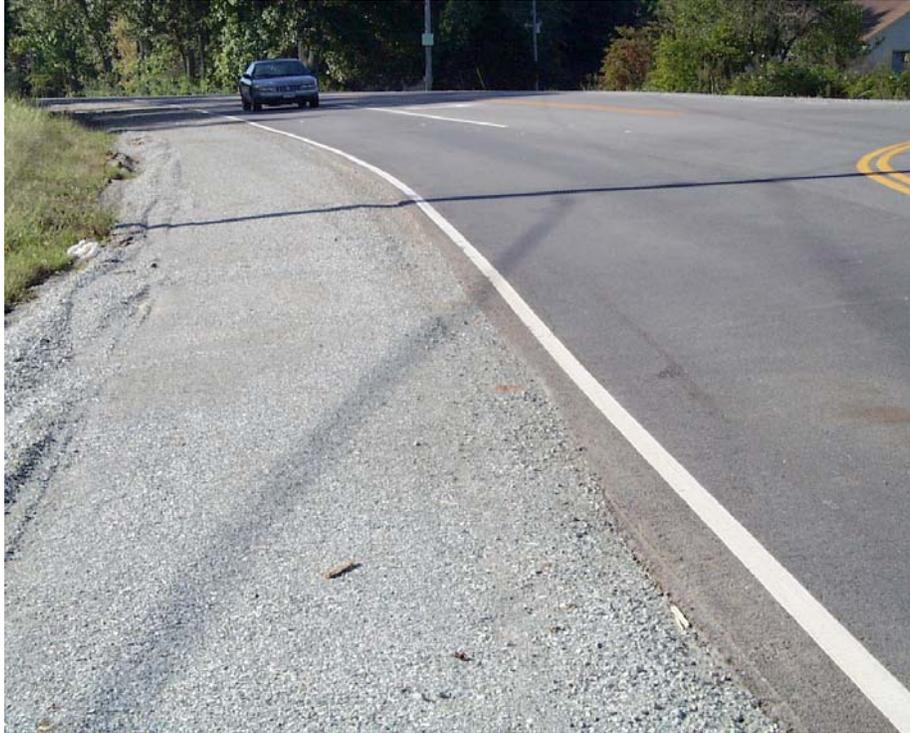
Figure 3. Low Shoulders along Soiltac Test Section, 9/21/2004

Findings from the visual inspections varied little over the life of the study. The findings of the initial inspection on September 14, 2004, are provided in Table 3. The September 21, 2004, inspection indicated a low unpaved shoulder drop-off over <25% of the Soiltac section length. Figure 3 indicates the magnitude of the condition. All low areas occurred on the curved section of roadway near the Route 651 intersection. The October 6, 2004, inspection indicated no further change in the test sections but low areas over <25% of the control section. Figure 4 indicates the magnitude of the condition.

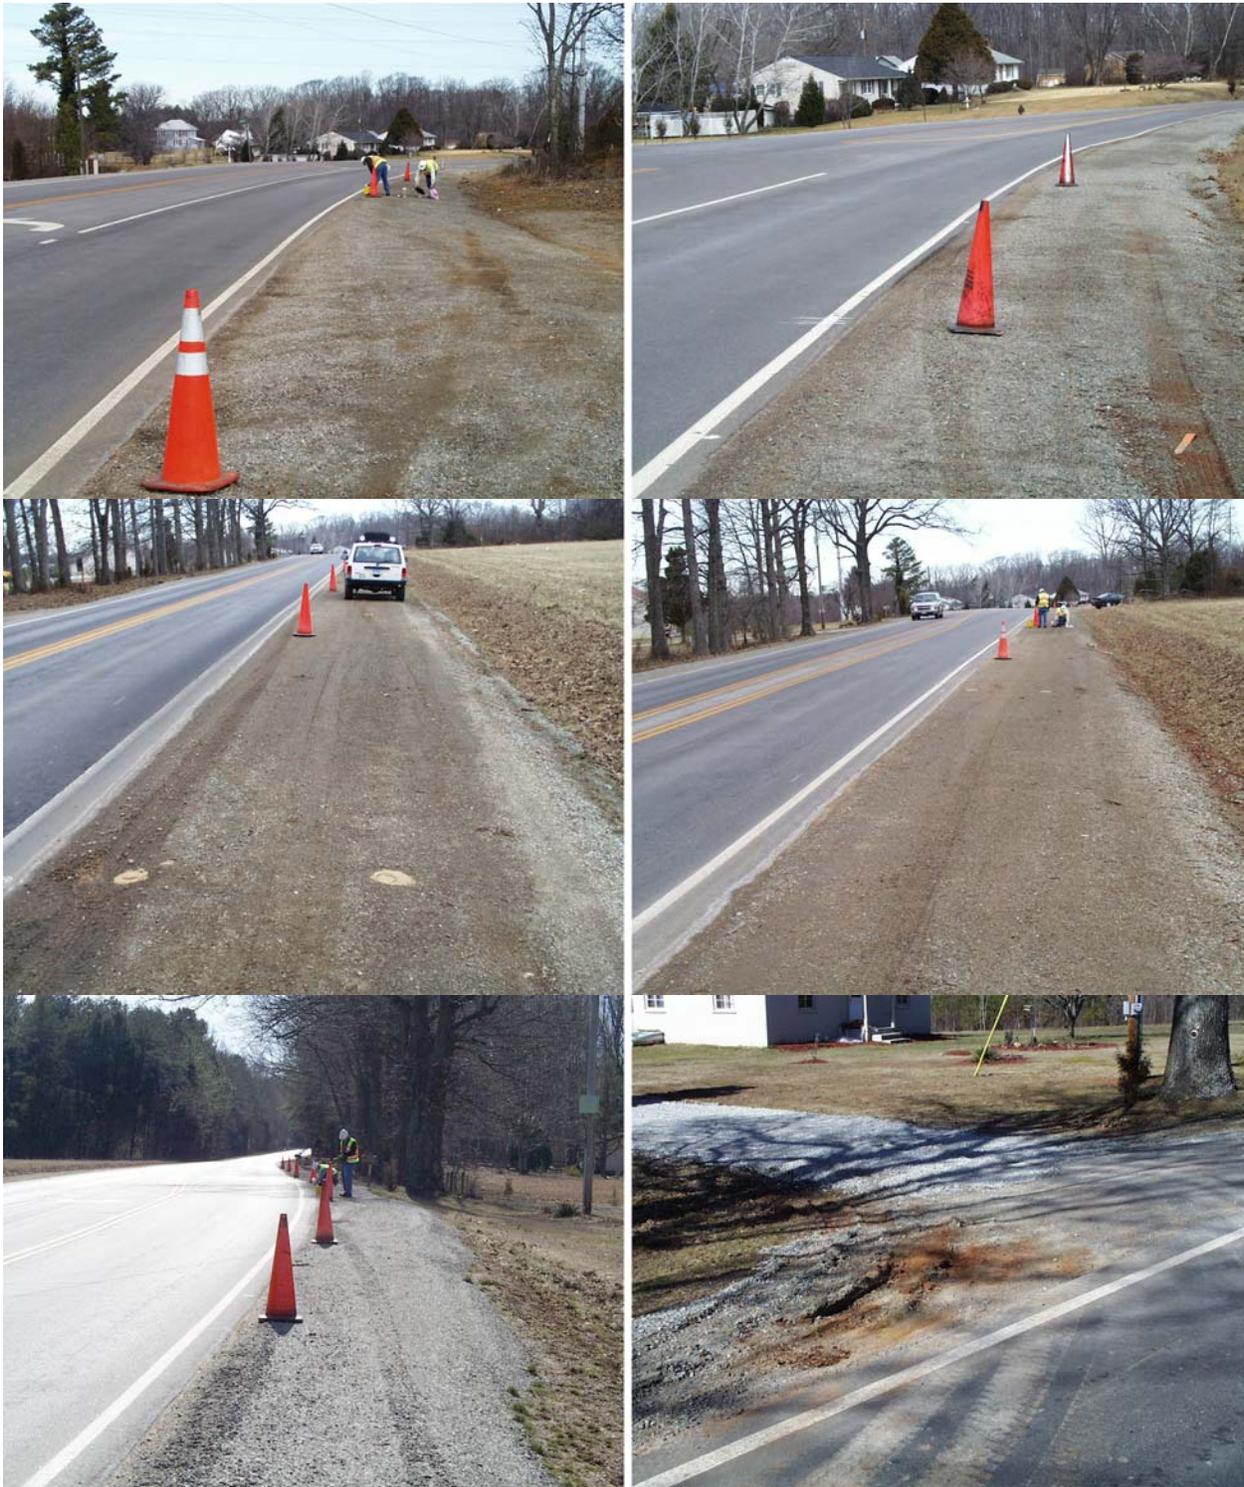
Figure 5. Test and Control Sections, 2/8/2005. *Top*, Soiltac; *middle*, Centrophase AD; *bottom*, control.

The rating form for February 8, 2005, indicated 25% to 50% of the Soiltac section had low shoulders and rutting over 50% of its length. The Centrophase AD section had rutting over 50% of its length. The control section had considerable damage at a private entrance but otherwise had not deteriorated further. Figure 5 shows the condition of the three sections. Notes from the February 8 visual inspection indicate the Centrophase AD and Soiltac sections were soft. Surface material was wet and rutted under the tire pressure of a sport utility vehicle. The control section was relatively dry and hard when compared to the test sections but showed signs of rutting.

When data were collected on February 8, the two test sections were visibly wet and the control section was relatively dry. Moisture samples taken at the time at an approximately 4-in depth are reported in Table 5. They support the visible evidence for the Soiltac section but not for the Centrophase AD section. A light snow fell on February 3 and 4. Evidence of chemical treatment existed along the edge of pavement adjacent to the Centrophase AD section but not along the control or Soiltac section.

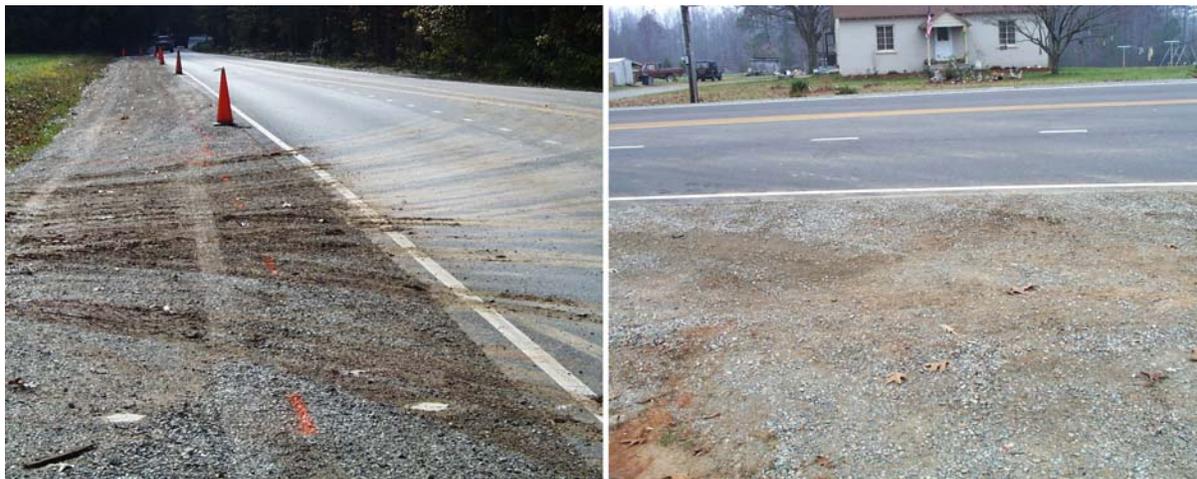
Figure 7. Conditions at Field Entrance on Two Dates. *Left, October 26; right, November 22.*

An unpaved field entrance exists across the Soiltac section. From early October to mid-November, the entrance was used intermittently by logging trucks. Data points 1 and 2 in the Soiltac section were in the path of the logging traffic. As with the private entrance in the control section, the stiffness data for all the Soiltac locations were compared with the mean for each data collection date. Only the stiffness value for data point 1 on October 26 exceeded 2 standard deviations from the mean. The data for that date were tightly distributed around the mean, and the standard deviation was only 22% of the value of the mean. Views of the entrance on October 26 and November 22 are shown in Figure 7. The log trucks did track some mud onto the

shoulder on that date, but no distress as defined by the RCA manual was noted on either date. Based on these facts, all stiffness data collected for the Soiltac section were retained in the analysis that follows.
